Internal erosion under spillway: a case study

In this paper we investigate the mechanism of the internal erosion caused in the right abutment of the Shahghasem dam's spillway. Shahghasem dam is an earthen dam located in Yasouj city, southwest of Iran. A significant hole and pipe was observed in the corner of the right abutment from upstream view. The soil foundation is granular which is cohesionless and susceptible for internal erosion and piping in some conditions. Going through details of the design maps has shown that Lane's criteria for selecting safe dimensions of the seepage control measures have not considered. To safely control of the destructive phenomena a supportive wall is designed to attach to the left section of the spillway in order to increase seepage length and also the pipe route of the erosion should be grouted with high quality concrete.

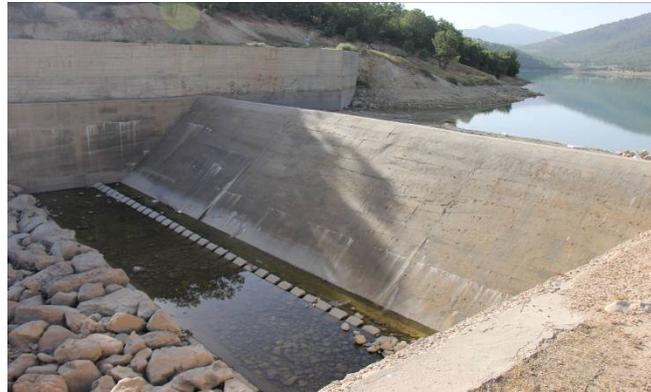
Figure 1 : Ogee spillway of Shahghasem dam

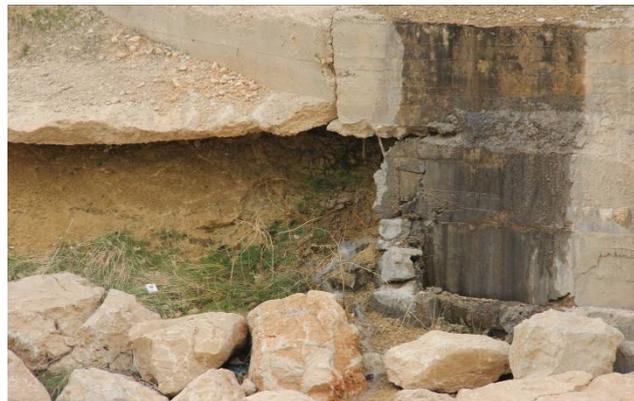
Shahghasem dam is an embankment dam which is located at Yasouj city, Kohgiluyeh and Boyer-Ahmad province southwest of Iran. Axes length of dam is 250m and the height of dam is 47.2m. The date of end of construction of the Shahghasem dam was 1995, and the dam was not filled due to drought period for 5 years. Recently field observation of the Shahghasem spillway has demonstrated local erosion occurred in the right abutment. Based on the geology of the dam site, in this part the predominant foundation material is marl which contains limestone with fine and homogenous grain size. The main thing is that the cohesion of this material is low, therefore is erodible. Looking at design reports showed that There was no watertight barrier between the concrete structure and the abutment or the embankment and also downstream filter to plug eroded particles. Figures 1 and 2 show the observed hole in downstream part of the spillway. With respect to time, expanding of the hole was significant. The main thing is that the seeping flow was clear water. Before

Figure 2 : piping hole and seeping flow between abutment and concrete body

The quantity of the seeped water was about 7 lit/sec which increases gradually with time. Since the soil foundation is erodible and susceptible therefore, there is a necessity to do remedial measures. As it mentioned before, the Lane's empirical method is used to evaluate piping phenomenon. Based on the dimensions of the wire and creeping length, Δh and L were determined by using as-built maps as 6 and 15m respectively. Using lane's criteria the C was computed 2.5 which are quite less than recommended values by Lane (1934). The recommended value for this type of soil is 4, so by this soil the creeping length should increased to 24. Form hydraulic and structural view point, concrete wall attached to main wall of spillway should be considered. The best case is an integrated approach to control erosion as well as piping. The first part is to attach a concrete wall to the main wall provided that the Lane's criterion is satisfied. The second remedial action is to fill the hole pipe with concrete and cement. Figures 4 shows final design and remedial action of piping under Shahghasem dam.
